AFWAL-TR-82-2121
Volume I

STRUCTURAL ELEMENT AND REAL BLADE IMPACT TESTING

UNIVERSITY OF DAYTON RESEARCH INSTITUTE
300 COLLEGE PARK AVENUE
DAYTON, OHIO 45469

FINAL REPORT FOR PERIOD OCTOBER 1977 - JUNE 1980

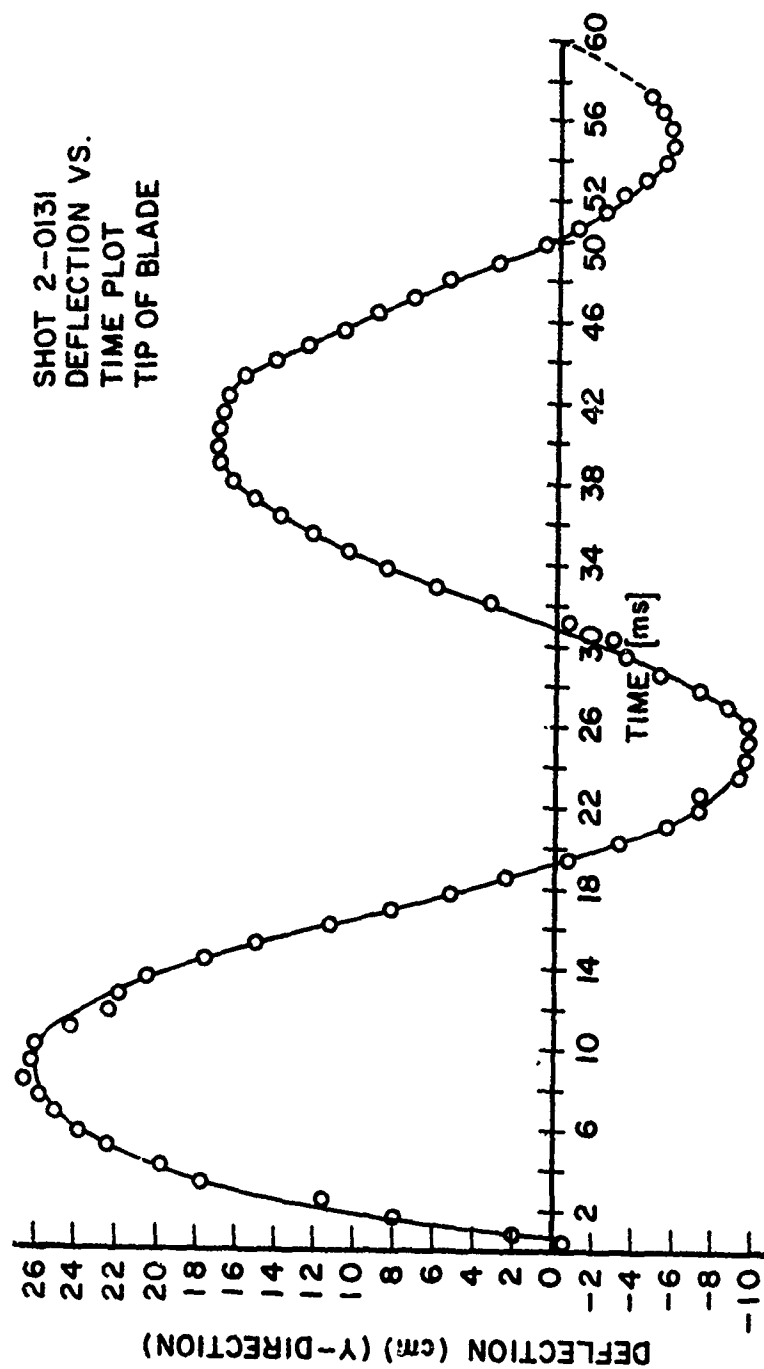
Figure 15. Tip Deflection Plot of Shot 2-0131.

Typical strain data for the Group 1 specimens is shown in Figures 8 through 13 (for Shot 2-0131). The strain gage locations on the specimen is given in Figure 7A of Appendix A. The 86 g bird normal impact at about the 70 percent location for Shot 2-0131 was at a velocity of 190 m/s. The damage generated of the specimen for this shot was plastic deflection at the root and impact site. The tip was displaced 5.69 cm. Figure 3B shows a photograph of the damage for this shot.

dynamic tip deflection versus time plot during the impact event for Shot 2-0131.

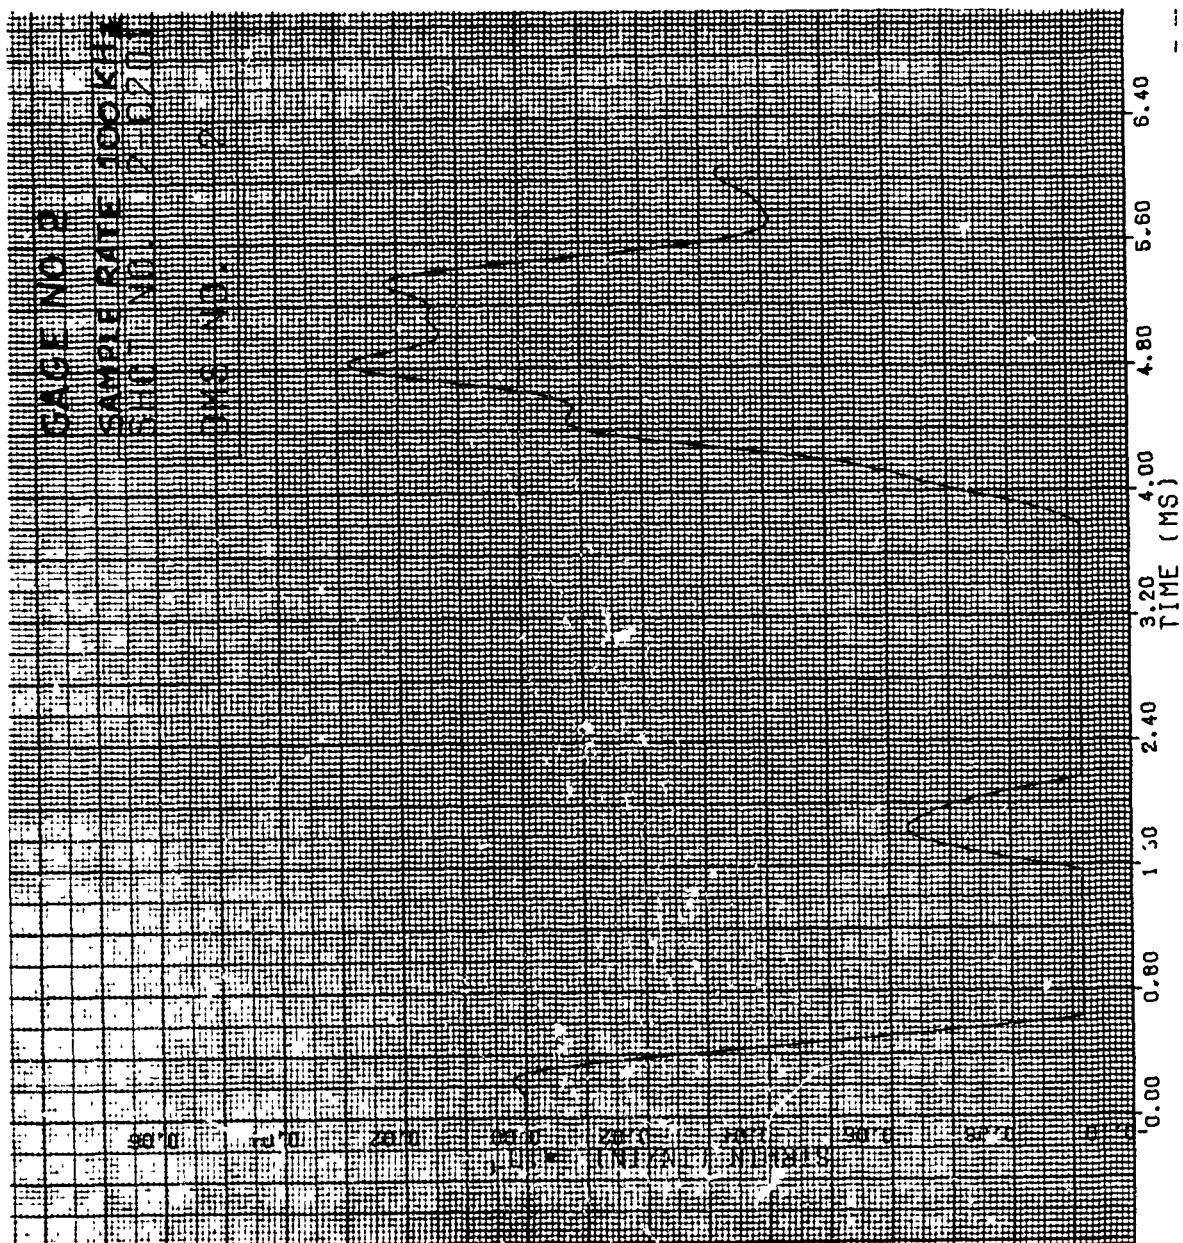
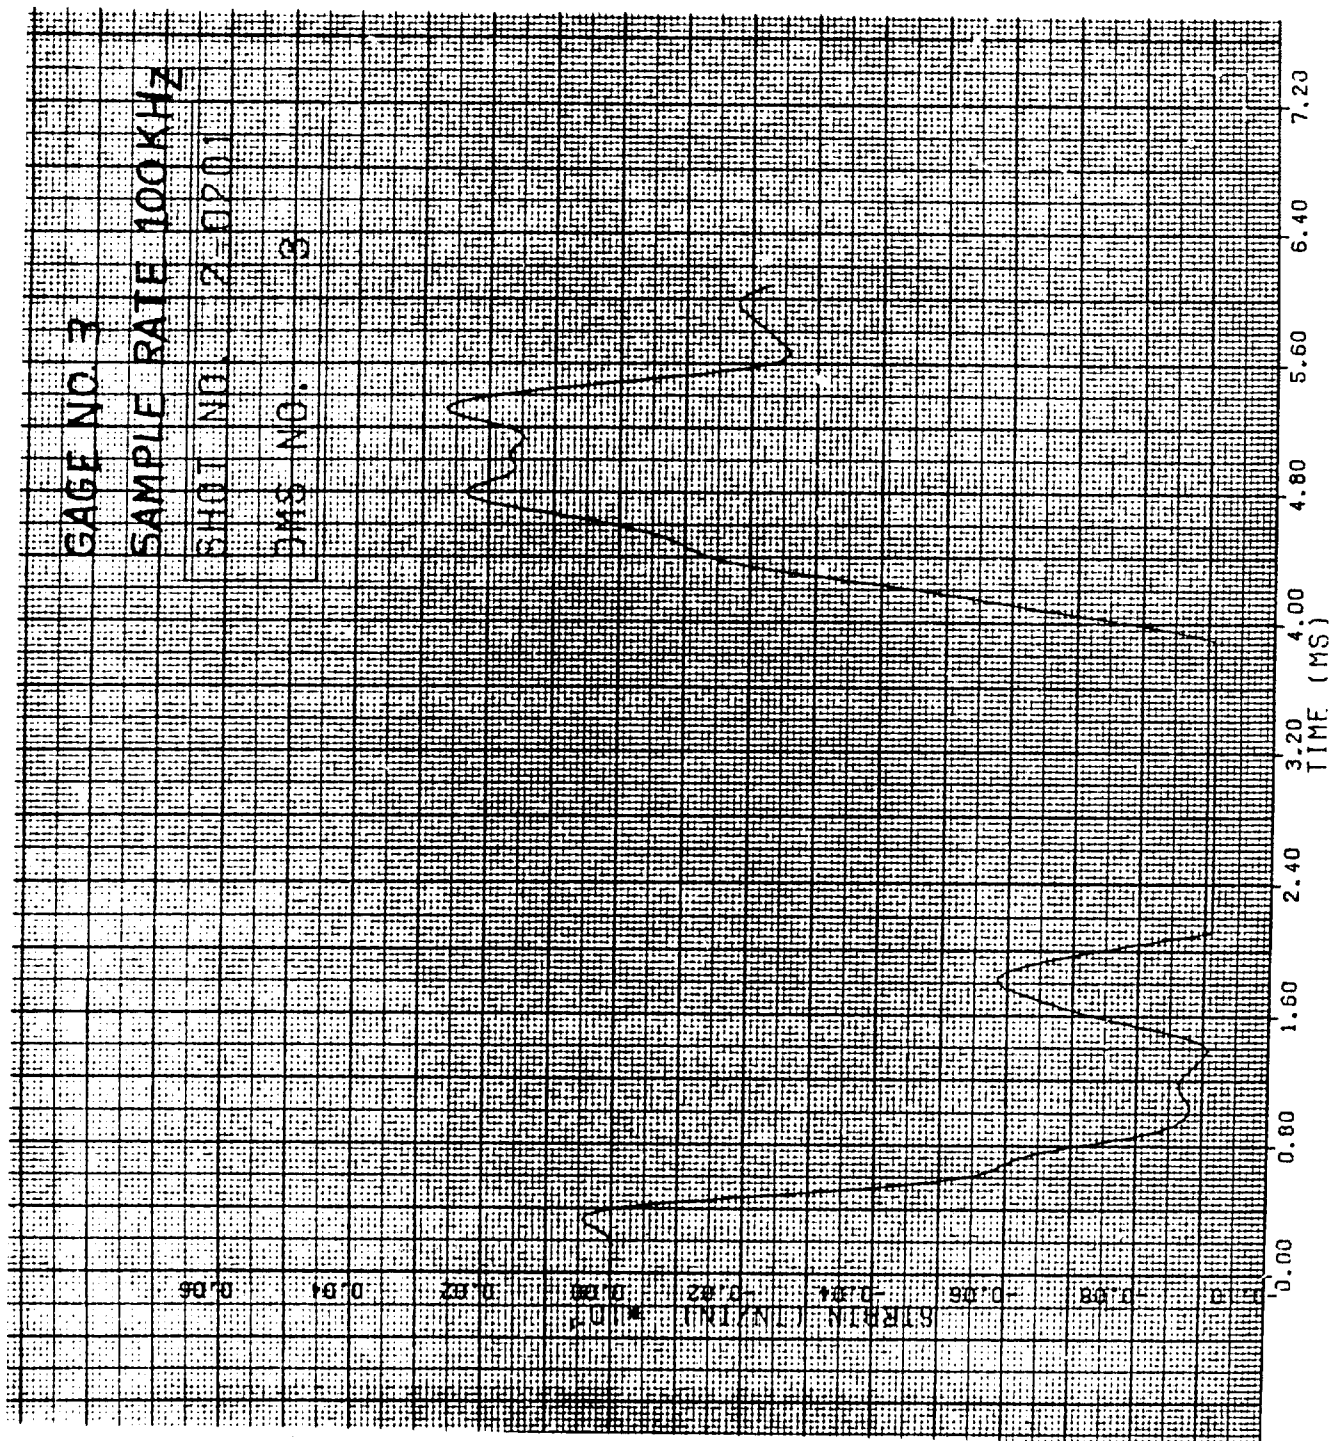
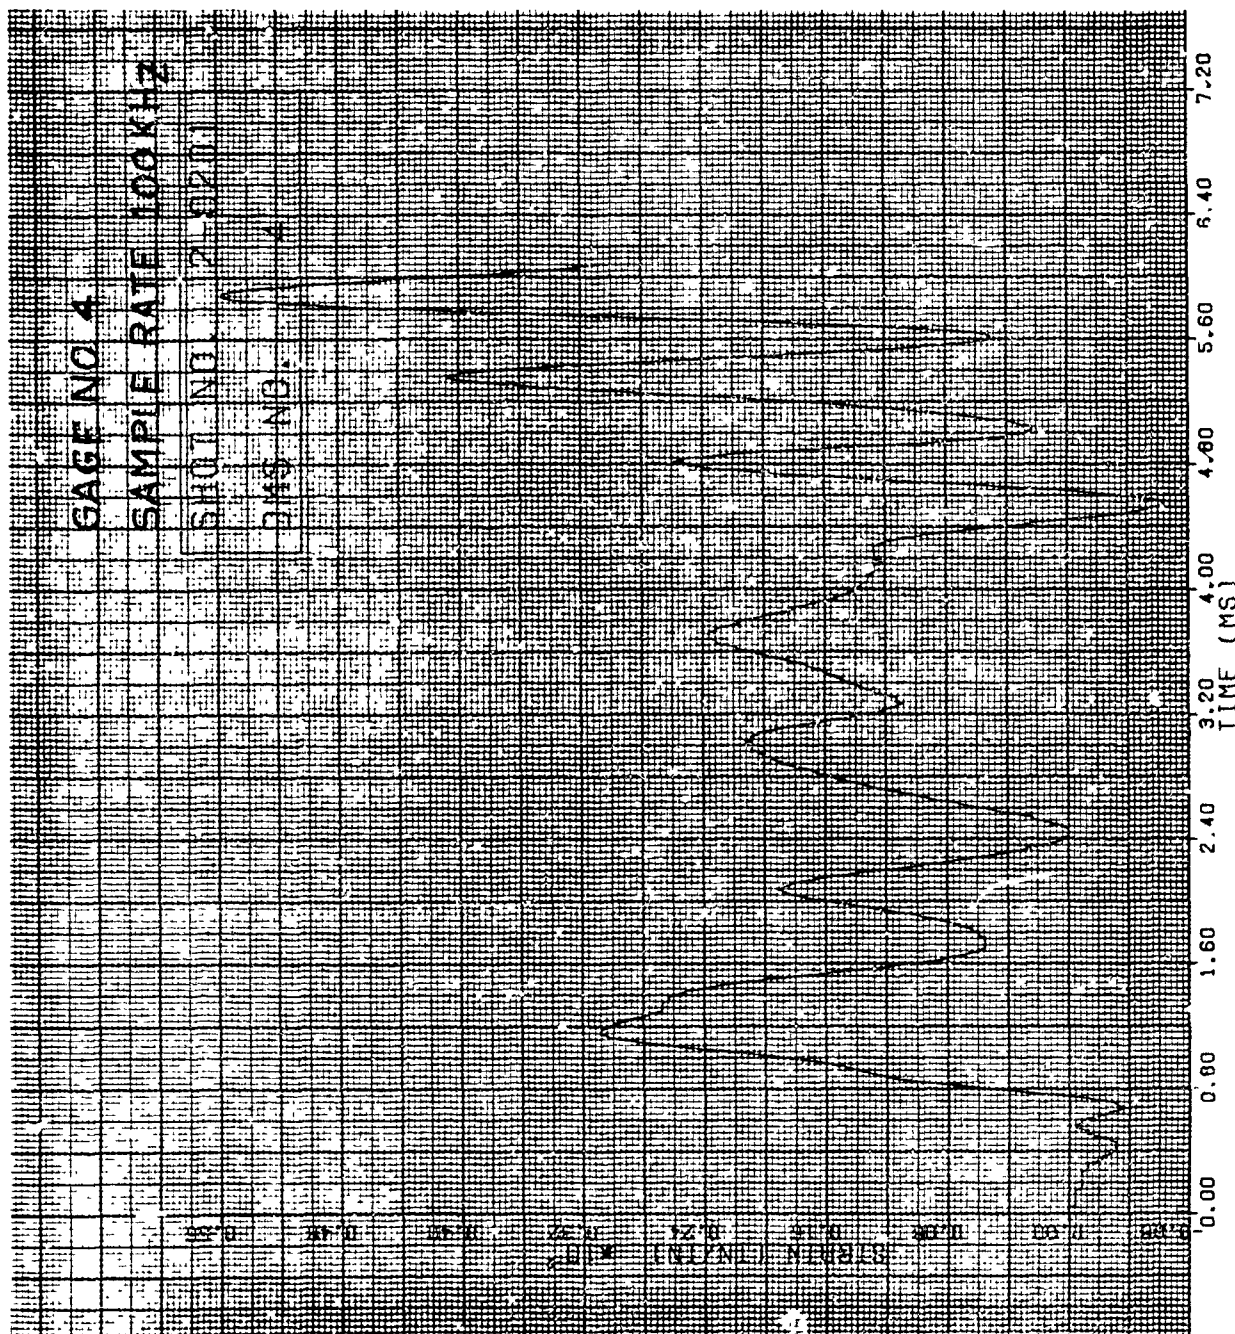
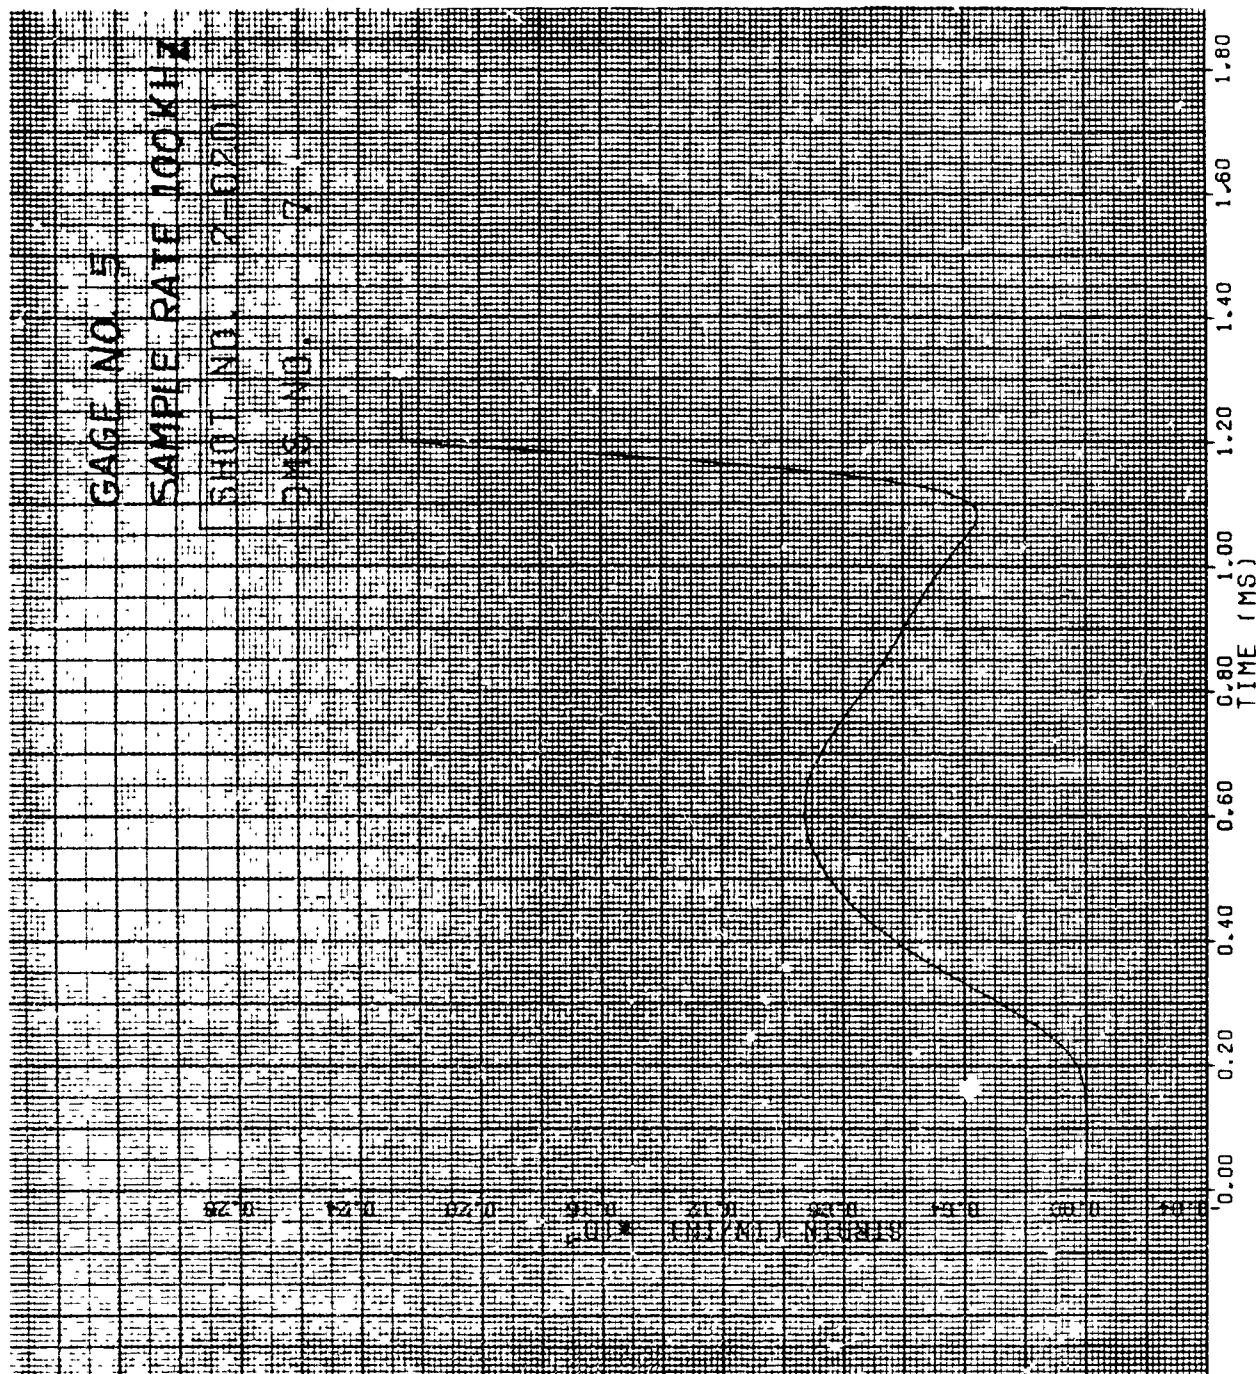
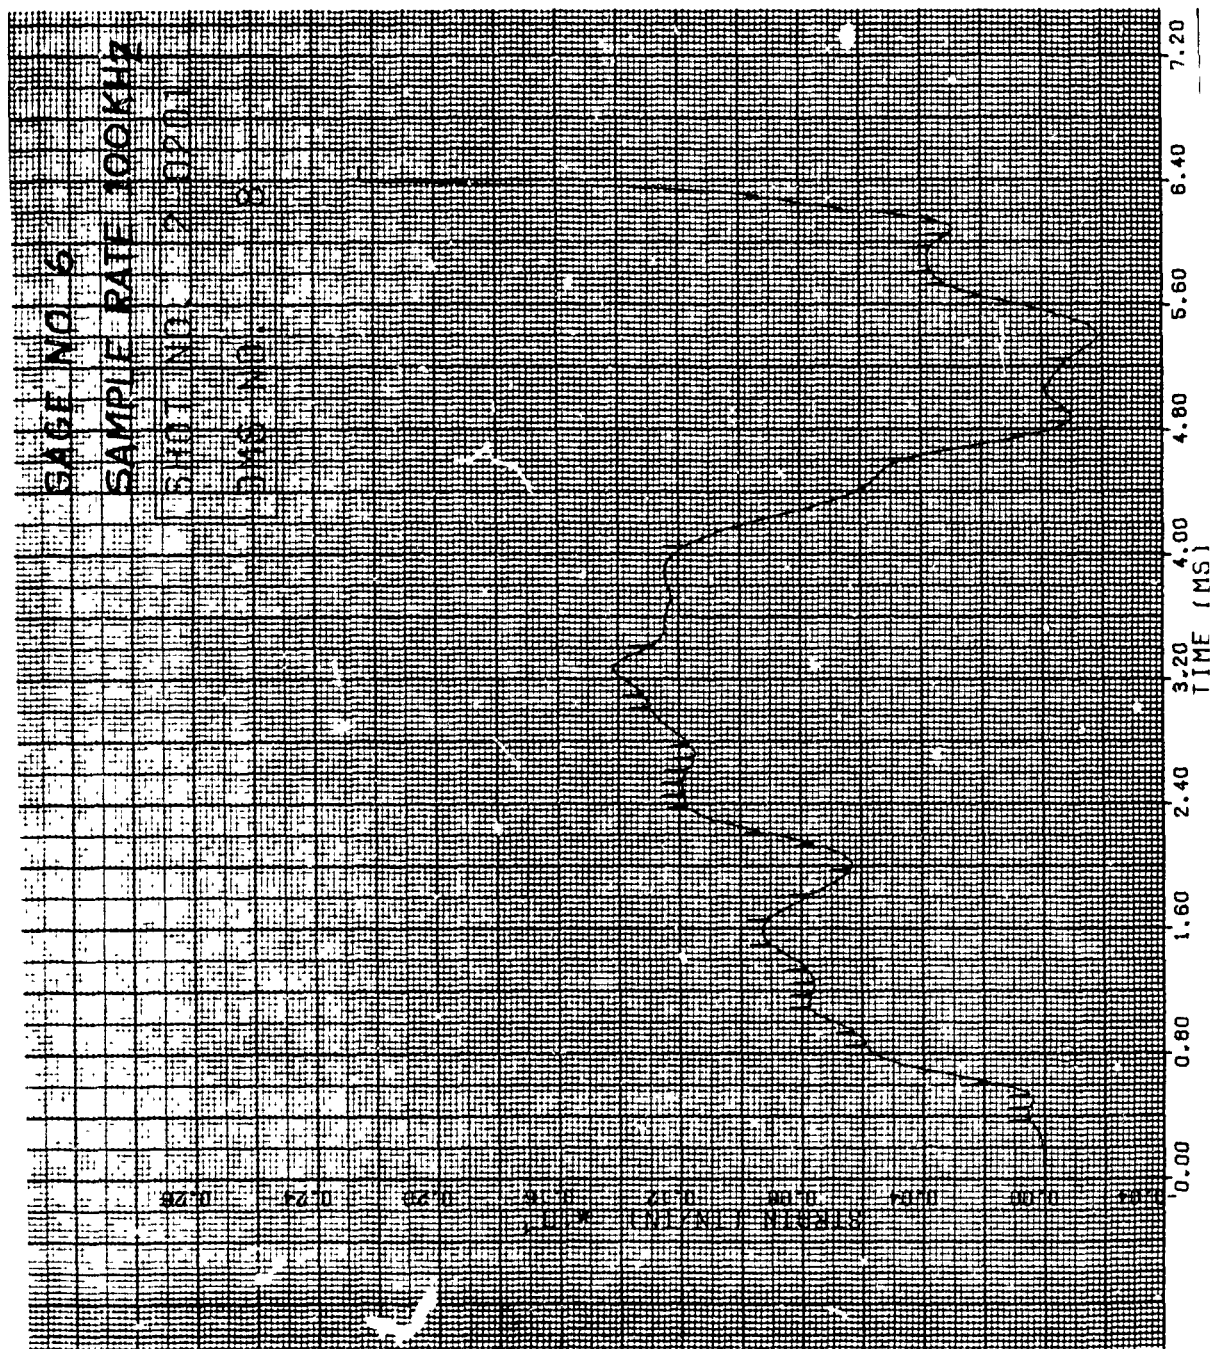
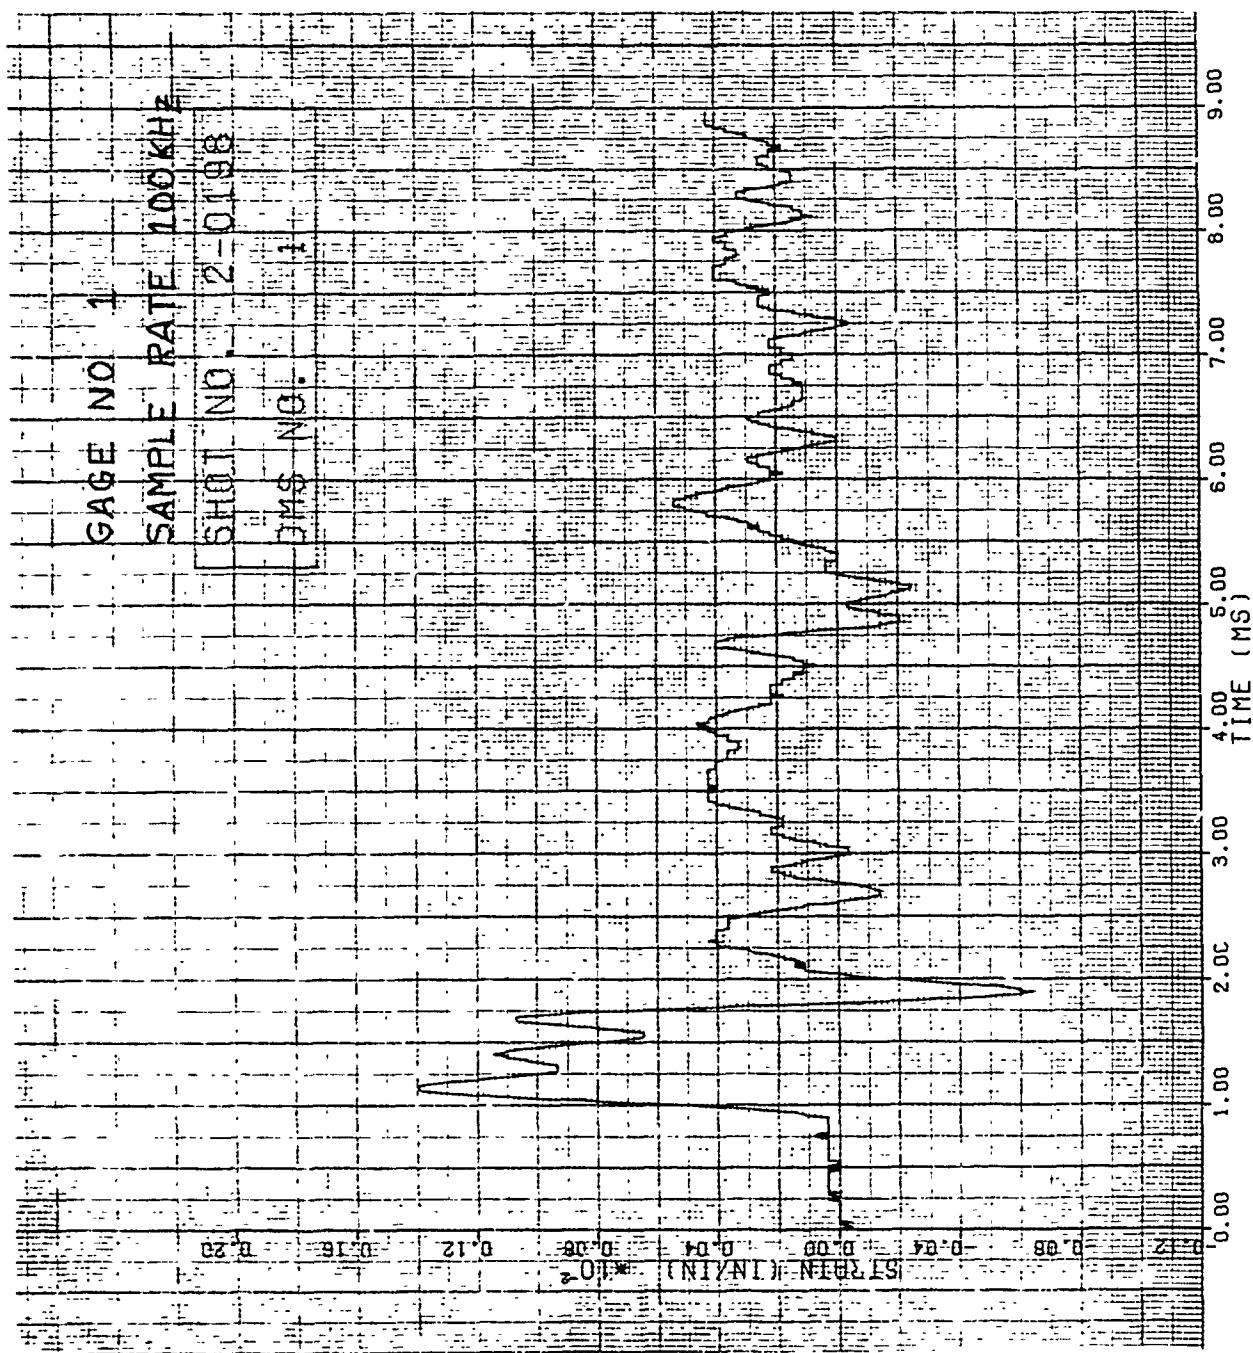
the impact site 1.78 cm for an impact mass of 105.6 g. Figure 46B shows the damage for Shot 2-0201. The strain data for Shot 2-0201 are given in Figures 186 through 191. The strain gage location for these impacts are given in Figure 4A of Appendix A. Tension for these impacts is denoted as a positive strain and compression as a negative strain.

Figure 186. Strain of Shot 2-0201 for Gage #1.

Figure 187. Strain of Shot 2-0201 for Gage #2.

Figure 188. Strain of Shot 2-0201 for Gage #3.

Figure 189. Strain of Shot 2-0201 for Gage #4.

Figure 190. Strain of Shot 2-0201 for Gage #5.

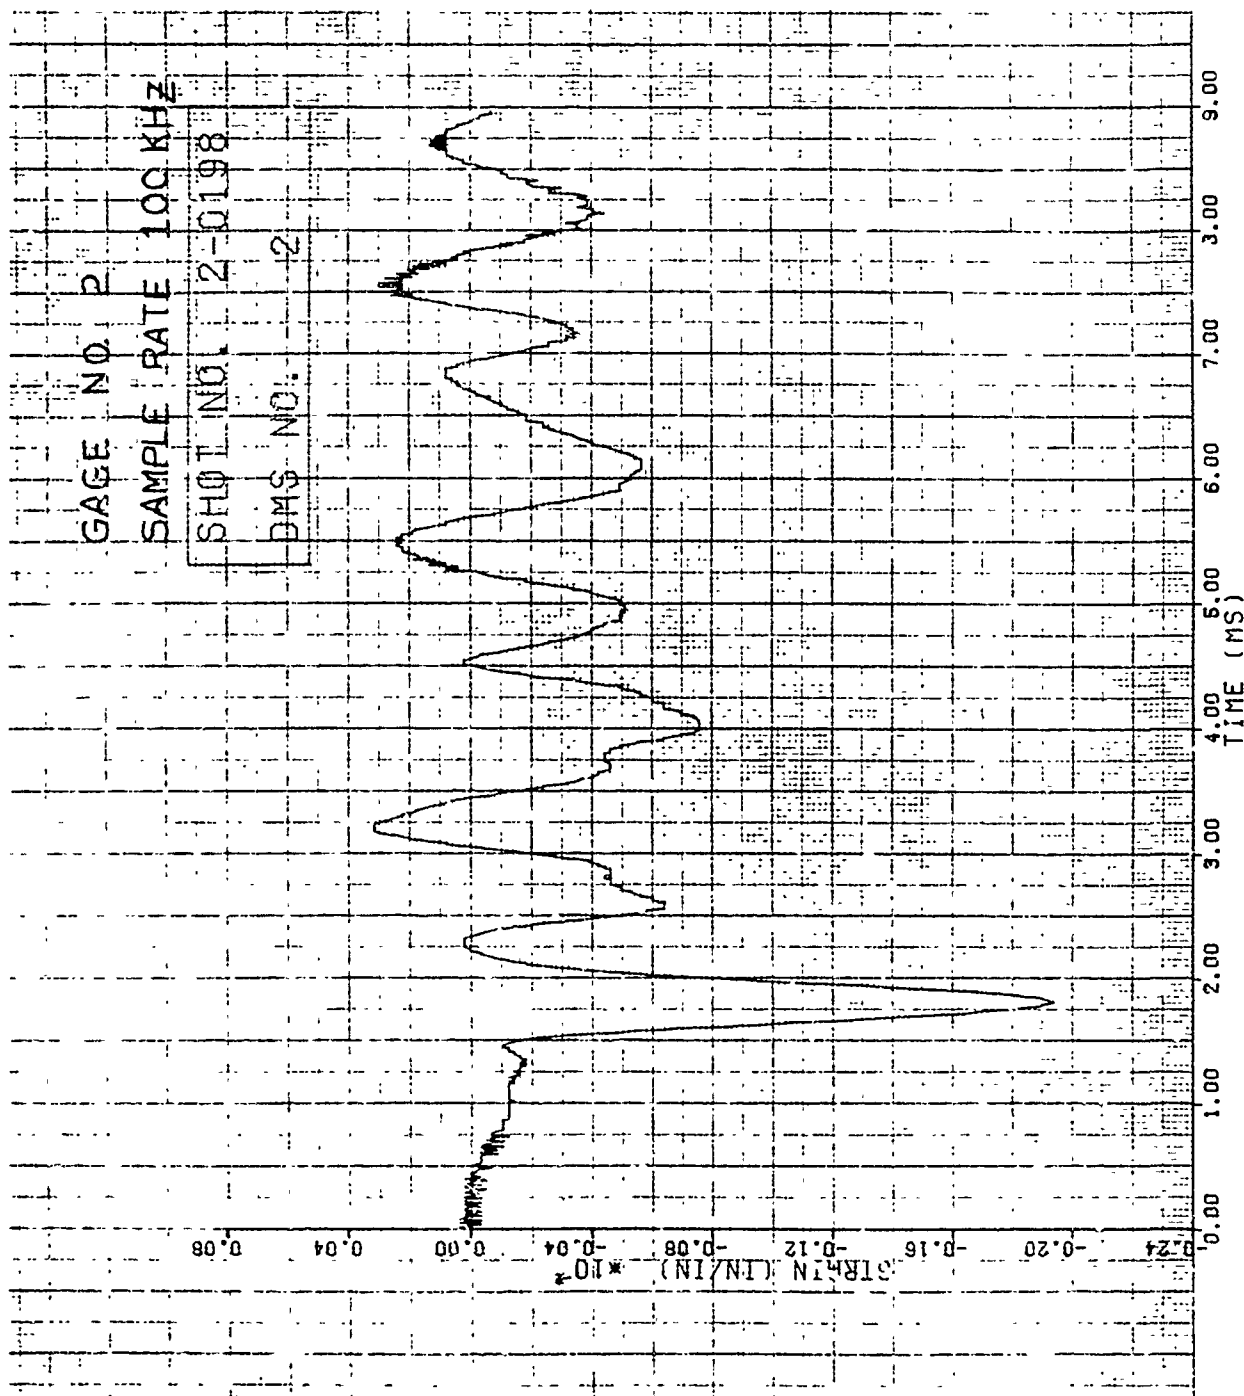
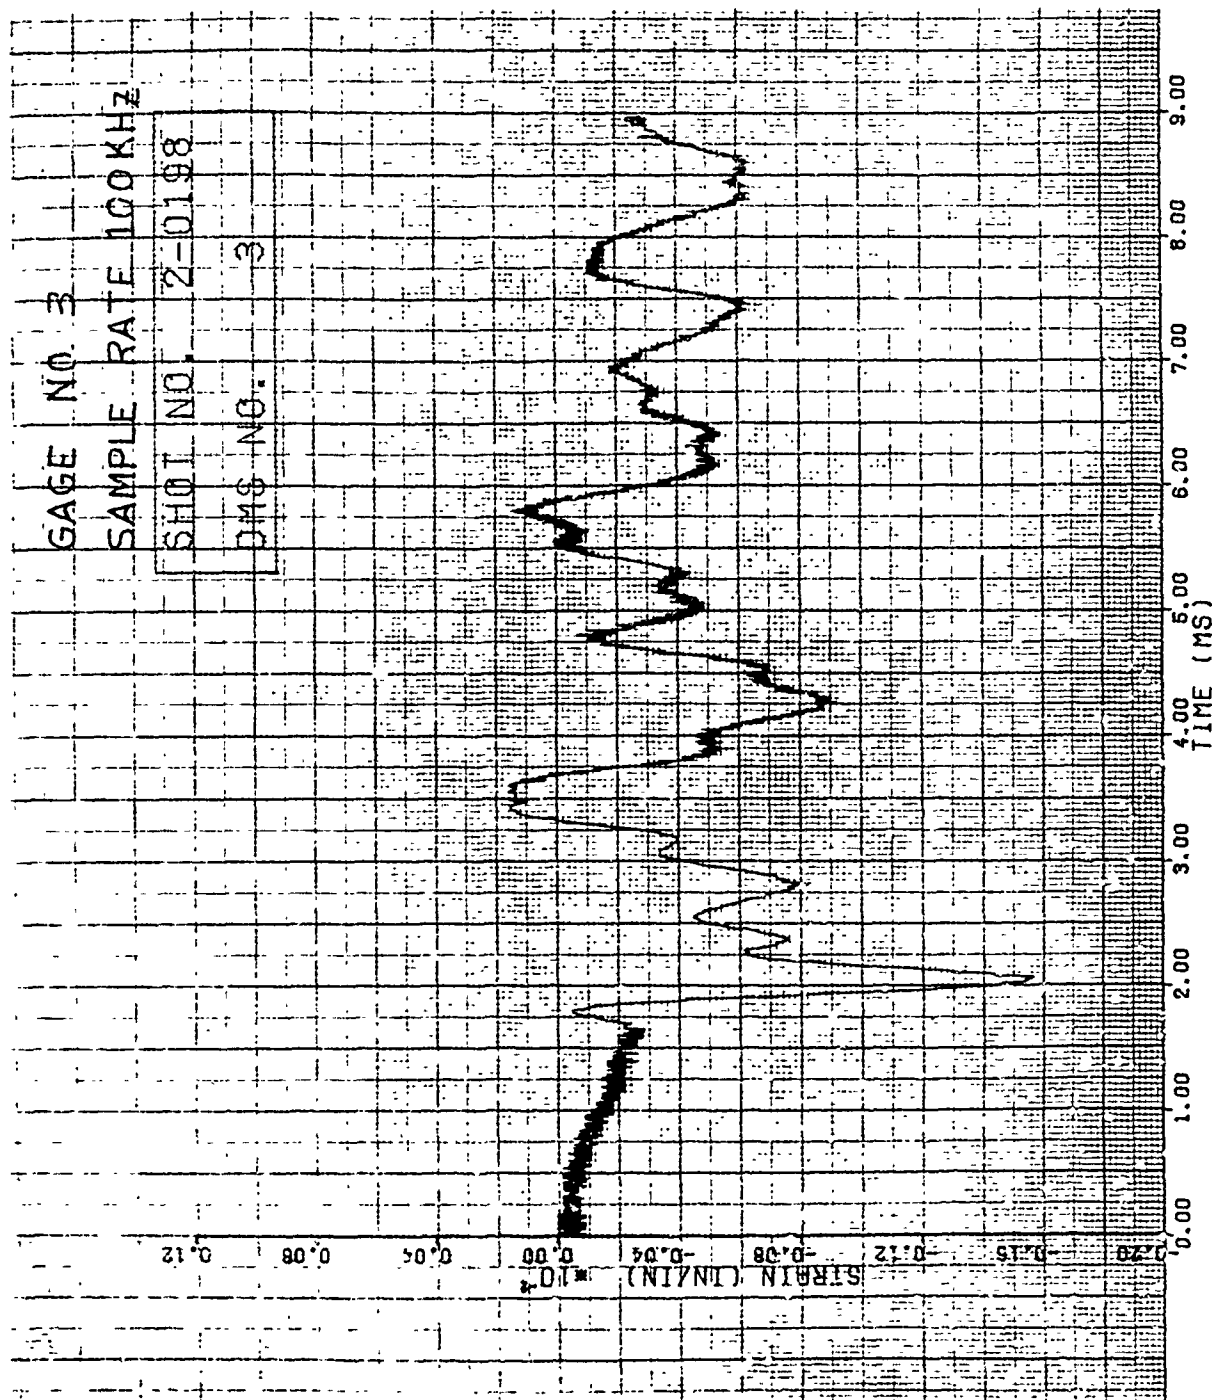
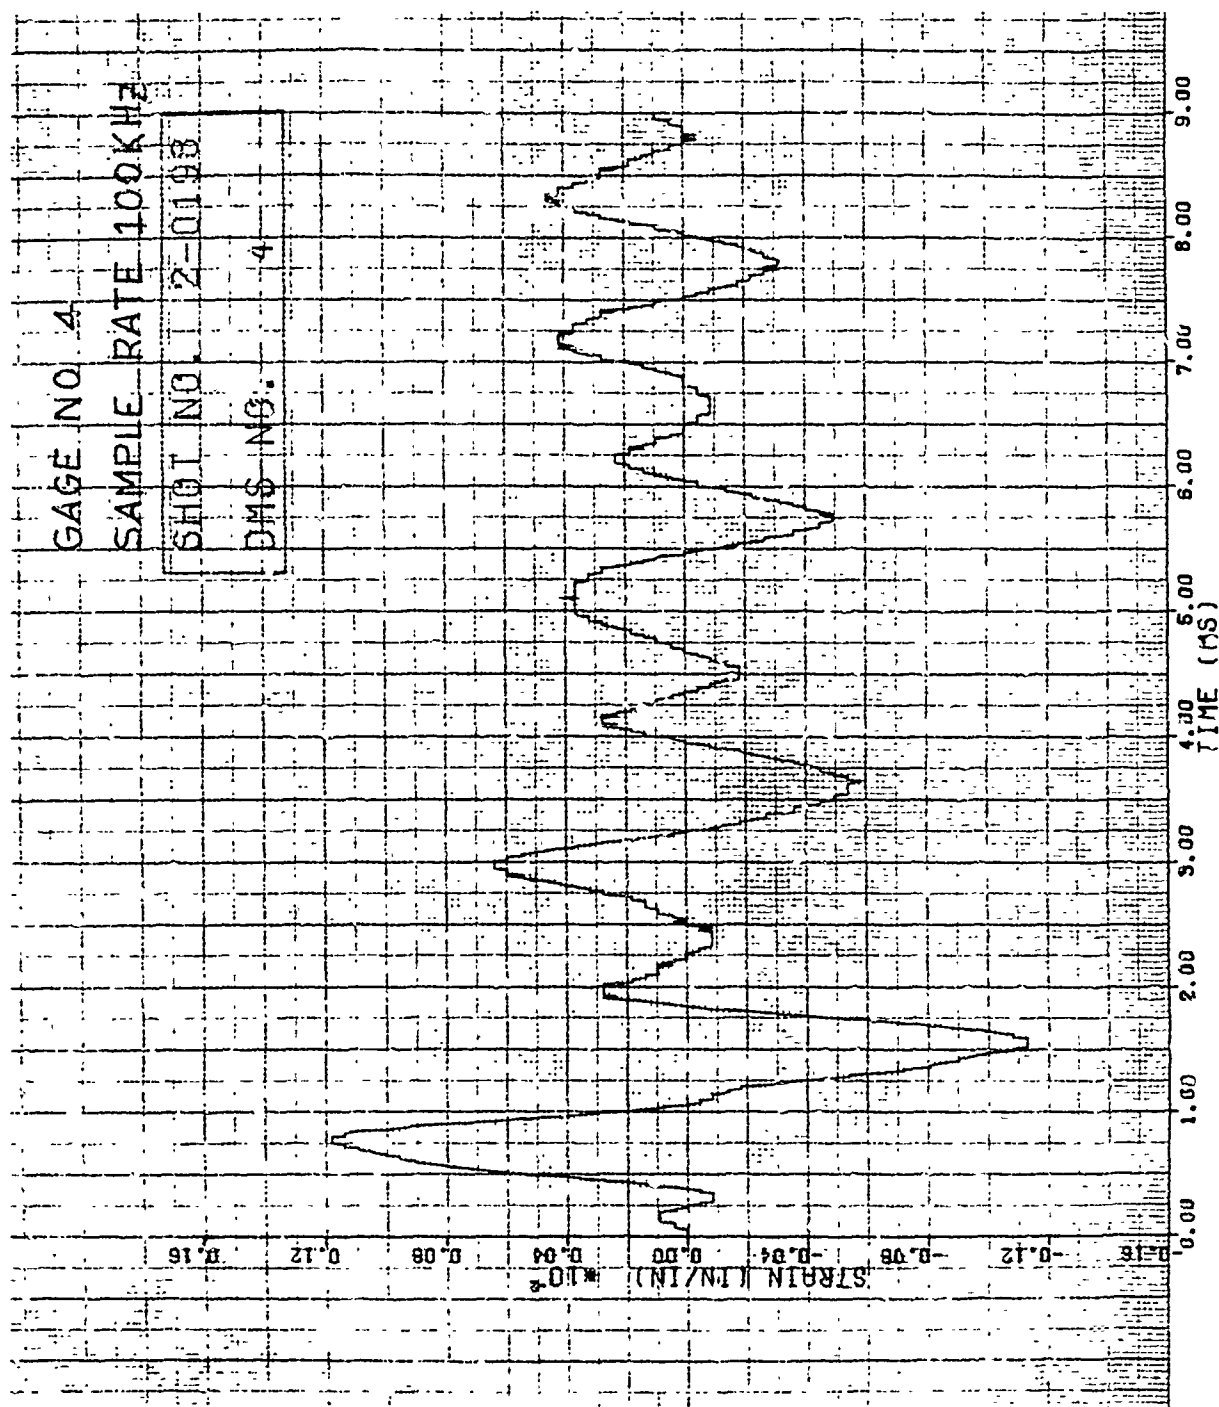
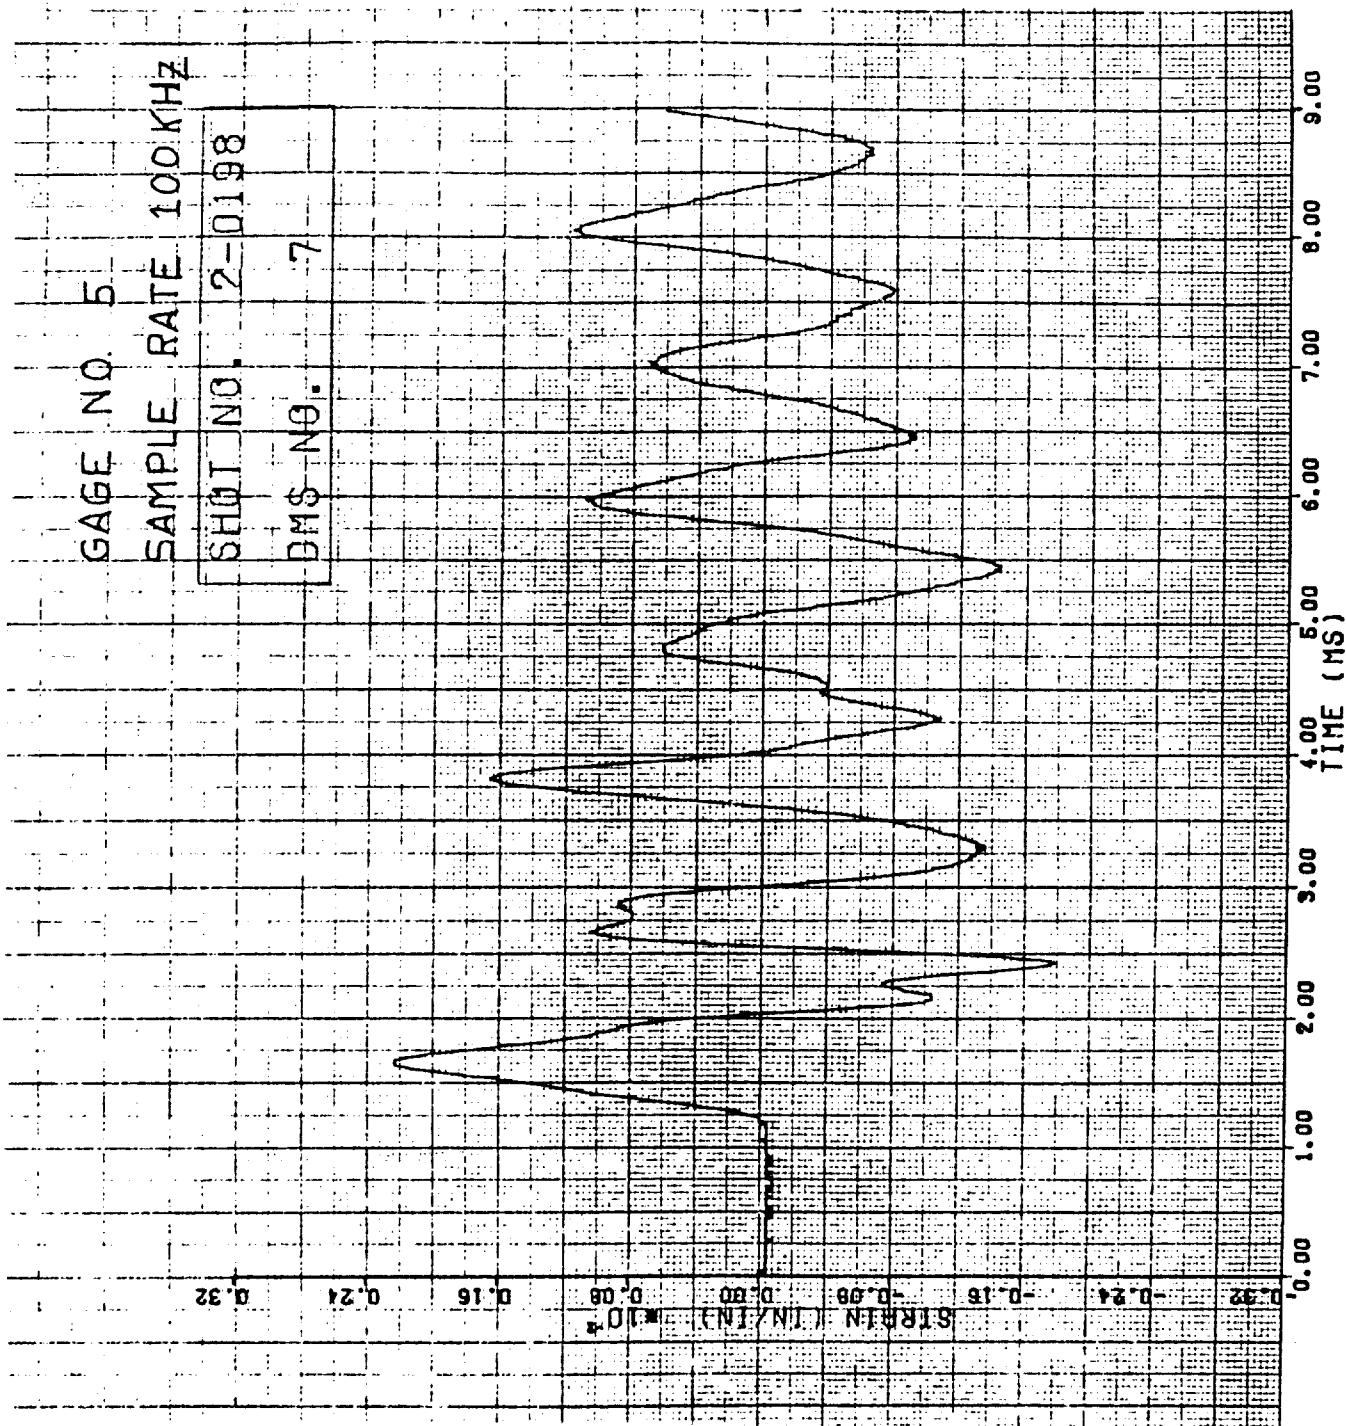
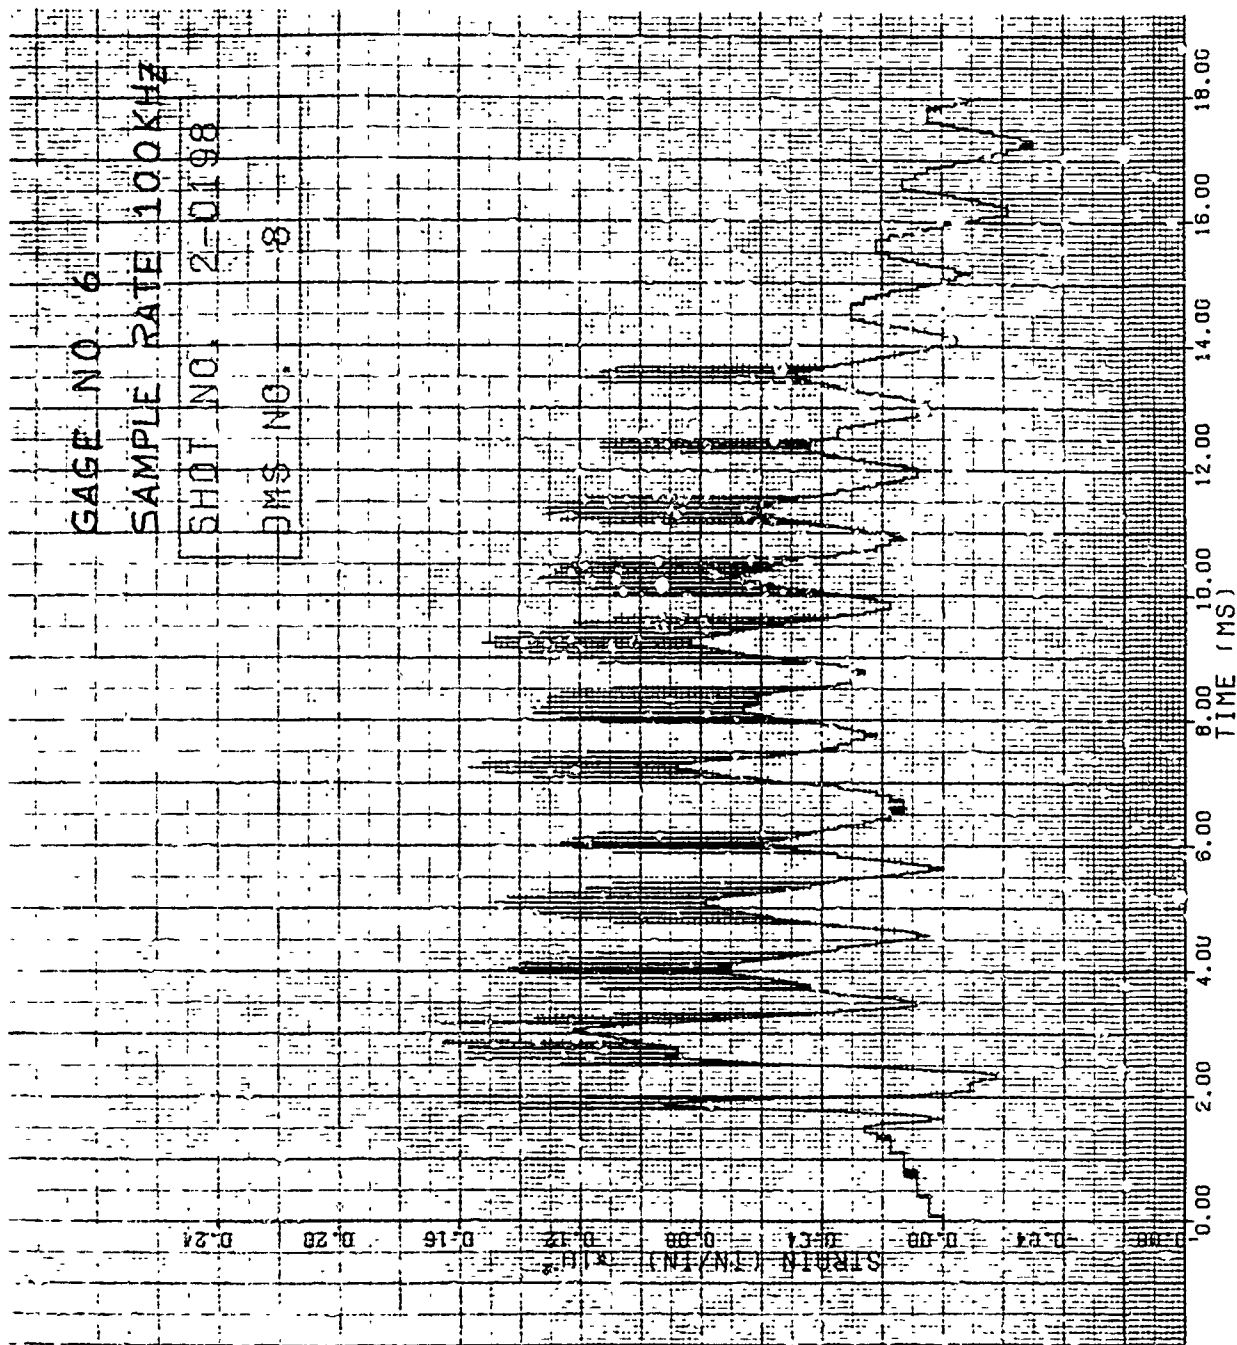
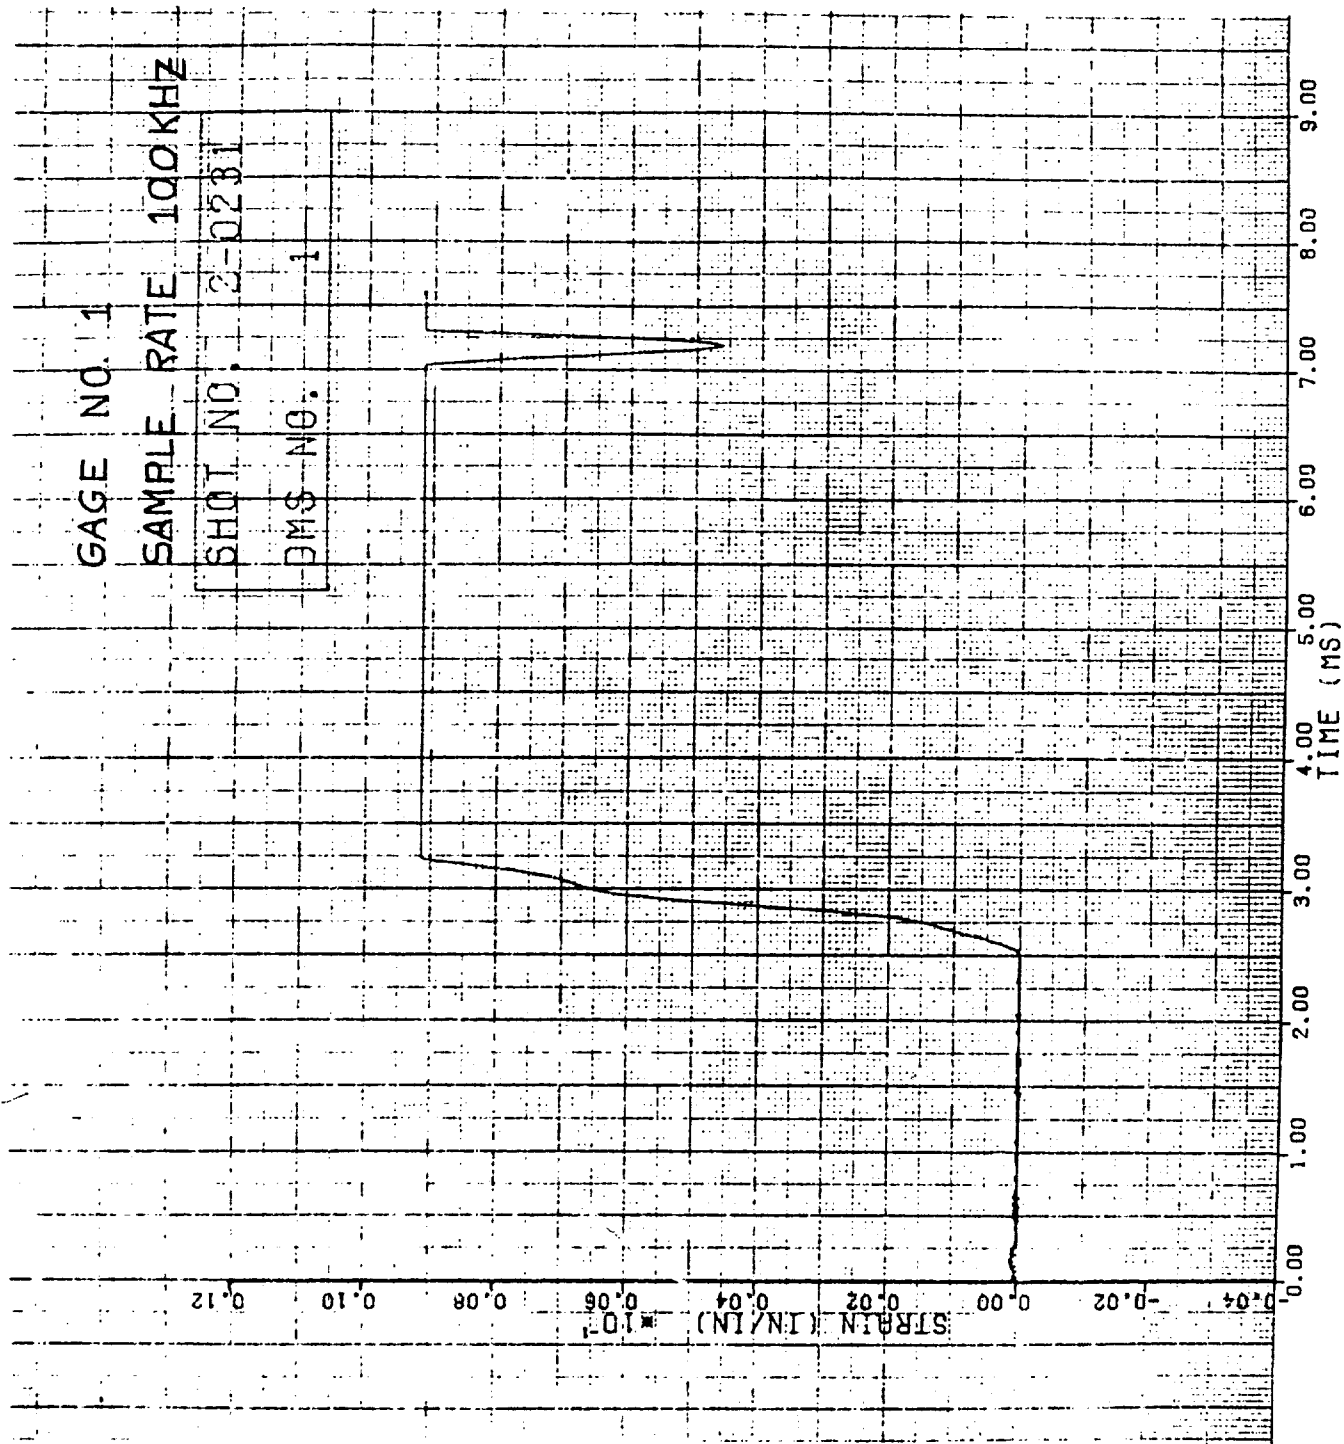
Typical strain curves are given in Figures 192 through 197 for Shot 2-0198. No visible damage was received for this impact at a velocity of 121 m/s and impact mass of 40.7 g.

Figure 192. Strain of Shot 2-0198 for Gage #1.

Figure 193. Strain of Shot 2-0198 for Gage #2.

Figure 194. Strain of Shot 2-0198 for Gage #3.

Figure 195. Strain of Shot 2-0198 for Gage #4.

Figure 196. Strain of Shot 2-0198 for Gage #5.
